Lake St. Martin Emergency Outlet Channel
Assessment of Effects and Development of Offsetting

Aquatic Habitat Supporting Volume (AHSV)

May 2015

A report prepared for
Manitoba Infrastructure and Transportation
by
North/South Consultants Inc. and KGS Group

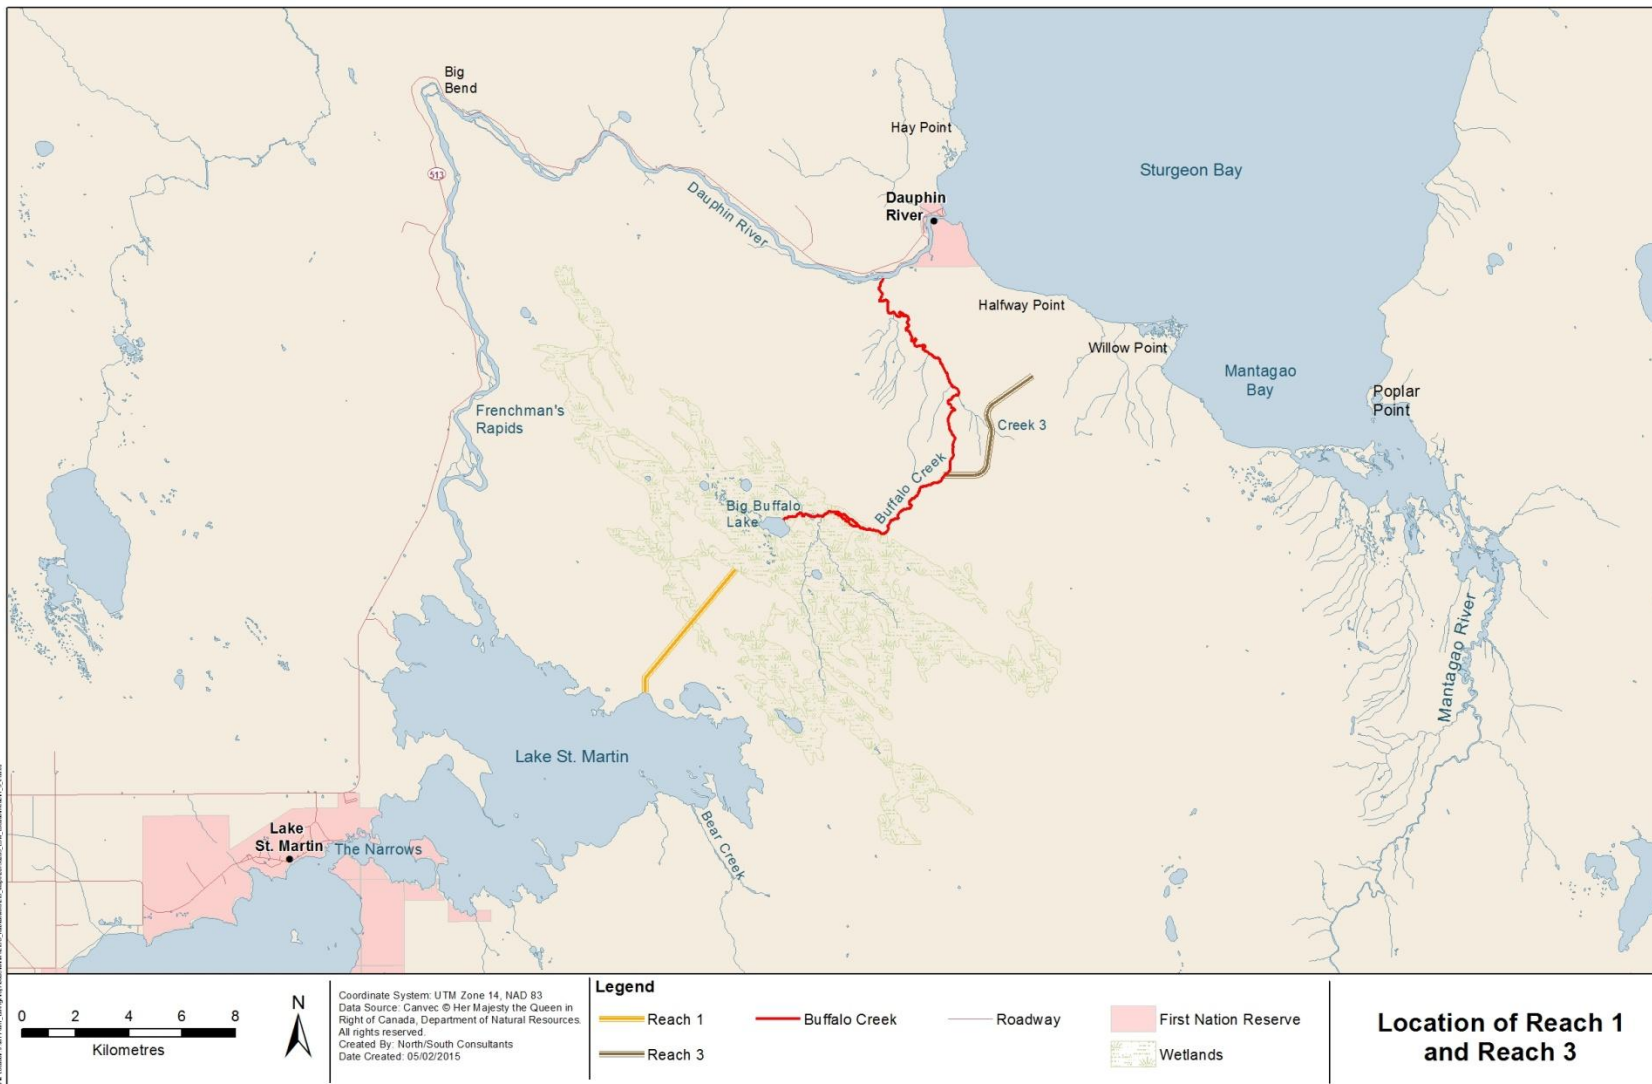
Figure 6.1-1. Location of the Reach 1 Emergency Outlet Channel, the Reach 3 Emergency Channel, and the Buffalo Creek Drainage System in relation to Lake St. Martin, the Dauphin River and Sturgeon Bay.

Widespread record flooding throughout southern Manitoba during 2011 led to water levels in Lake Manitoba and Lake St. Martin that were several feet higher than desirable, resulting in significant damage to hundreds of properties, restricted road access to several communities, and long-term evacuation of four First Nations communities in the vicinity of Lake St. Martin. As part of emergency relief measures, the Province of Manitoba, through Manitoba Infrastructure and Transportation (MIT), constructed the Lake St. Martin Emergency Outlet Channel System (LSMEOC system), which is comprised of two emergency channels (Figure 6.1-1).

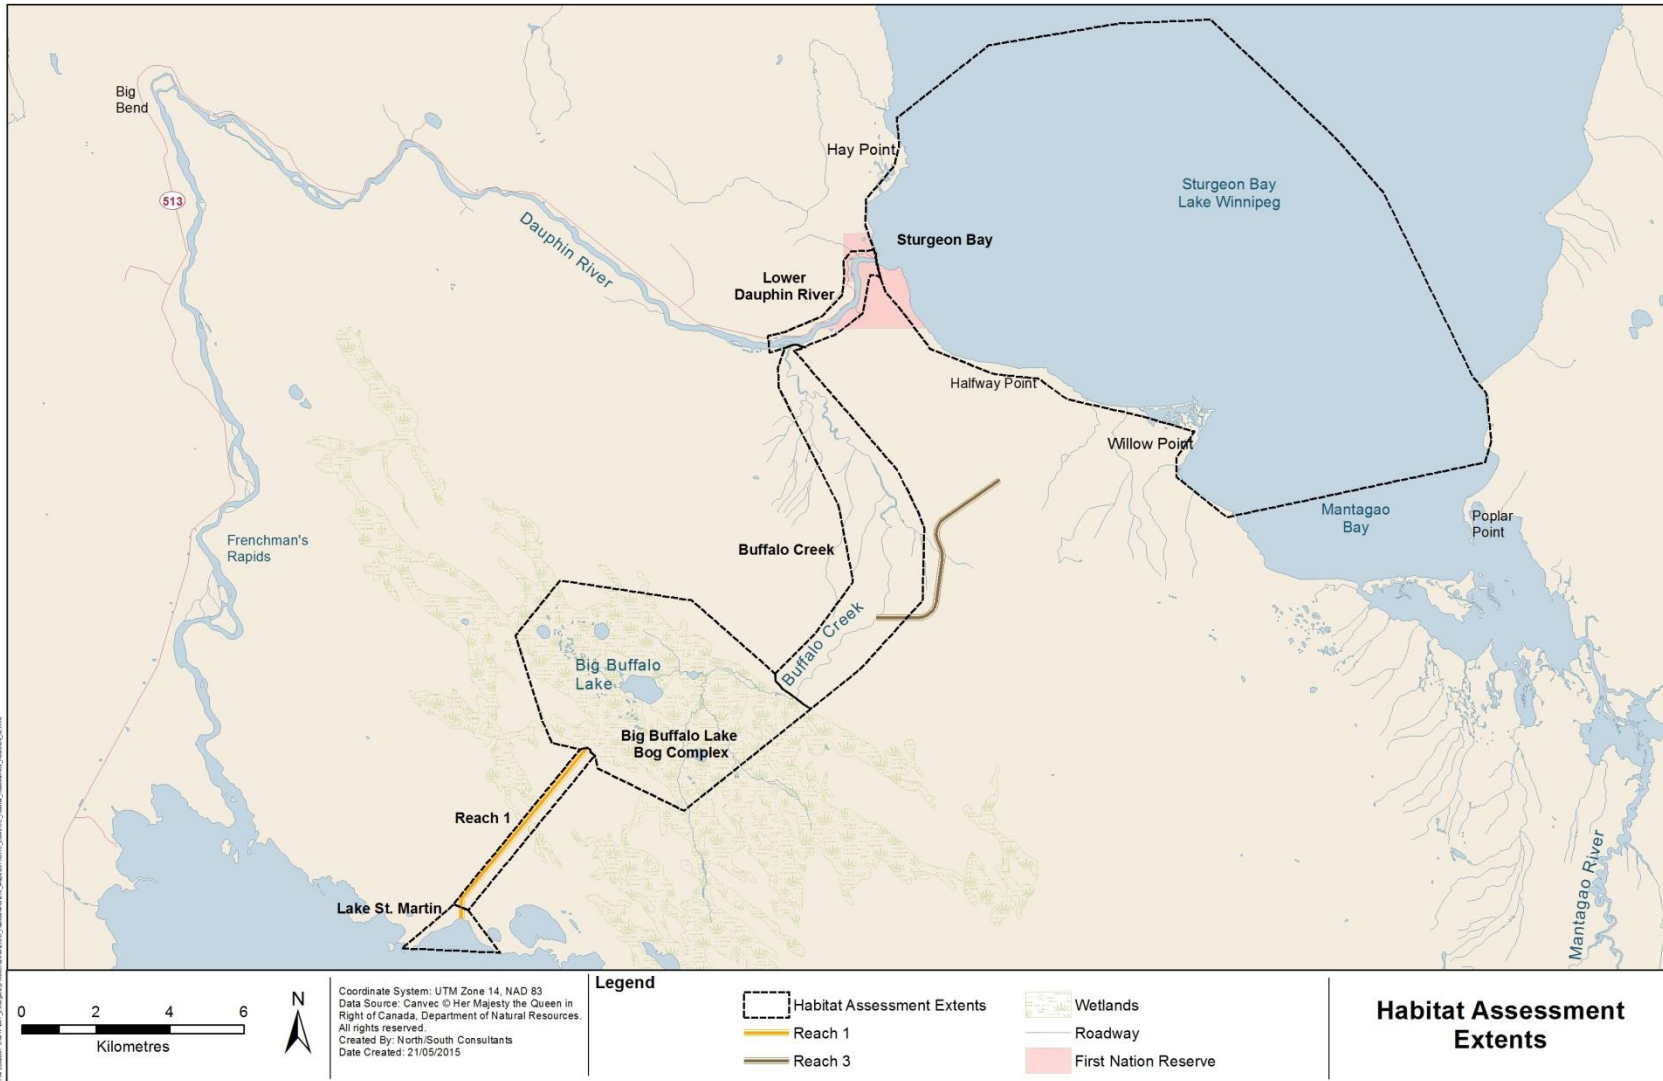
Figure 6.1-2. Waterbody extents identified for the aquatic habitat component of the effects assessment.

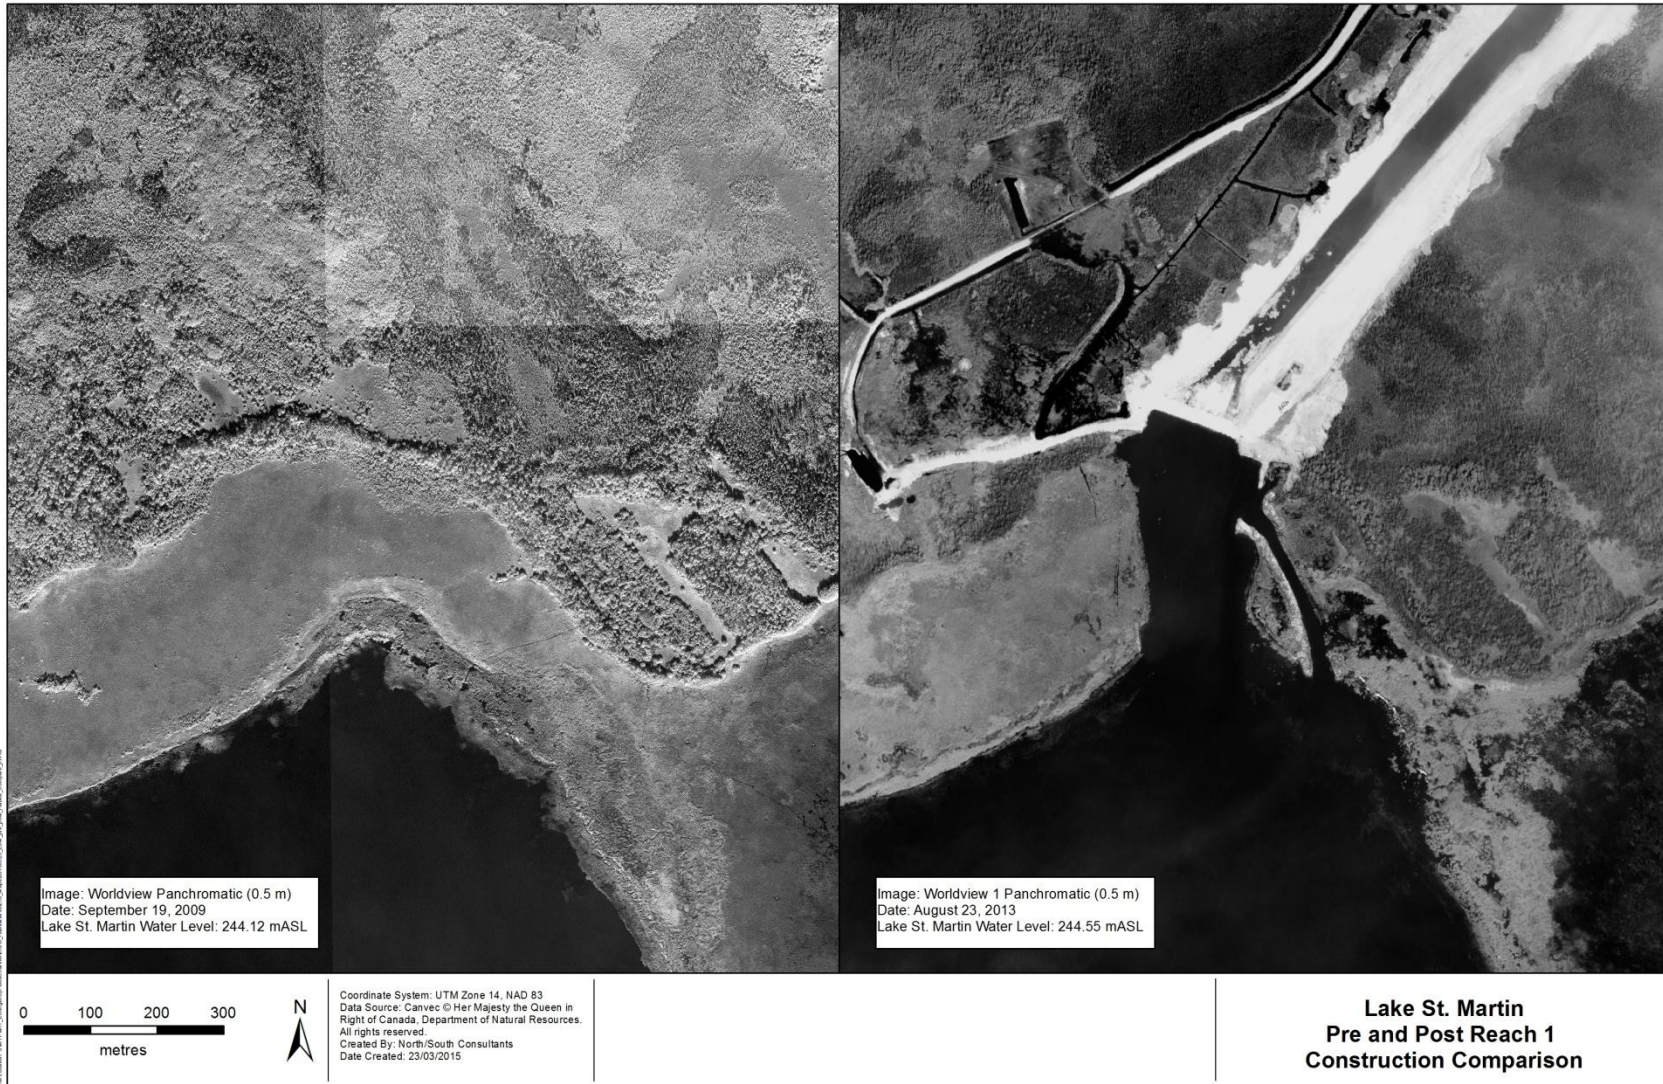
Figure 6.3-1. DigitalGlobe™ Wordview-1 Satellite image showing the area of Lake St. Martin prior to construction of Reach 1, and during 2011/2012 Closure.

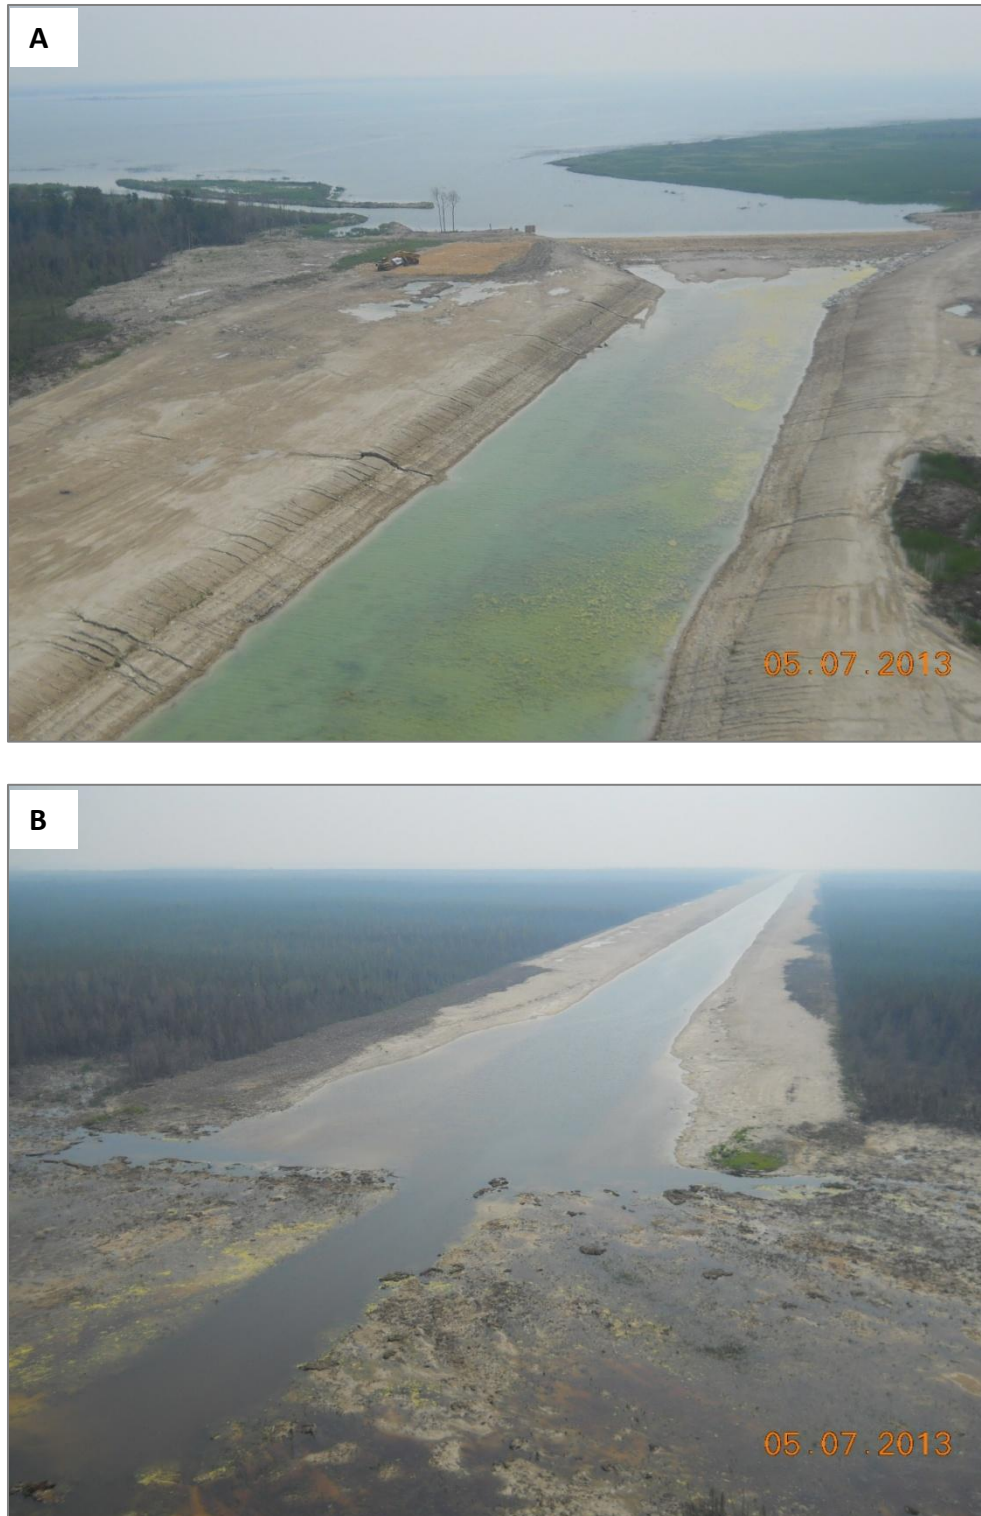
Figure 6.4-4. Aerial photographs of the Reach 1 at the (A) inlet from Lake St. Martin, and (B) outlet into the Big Buffalo bog complex during 2011/2012 Closure.

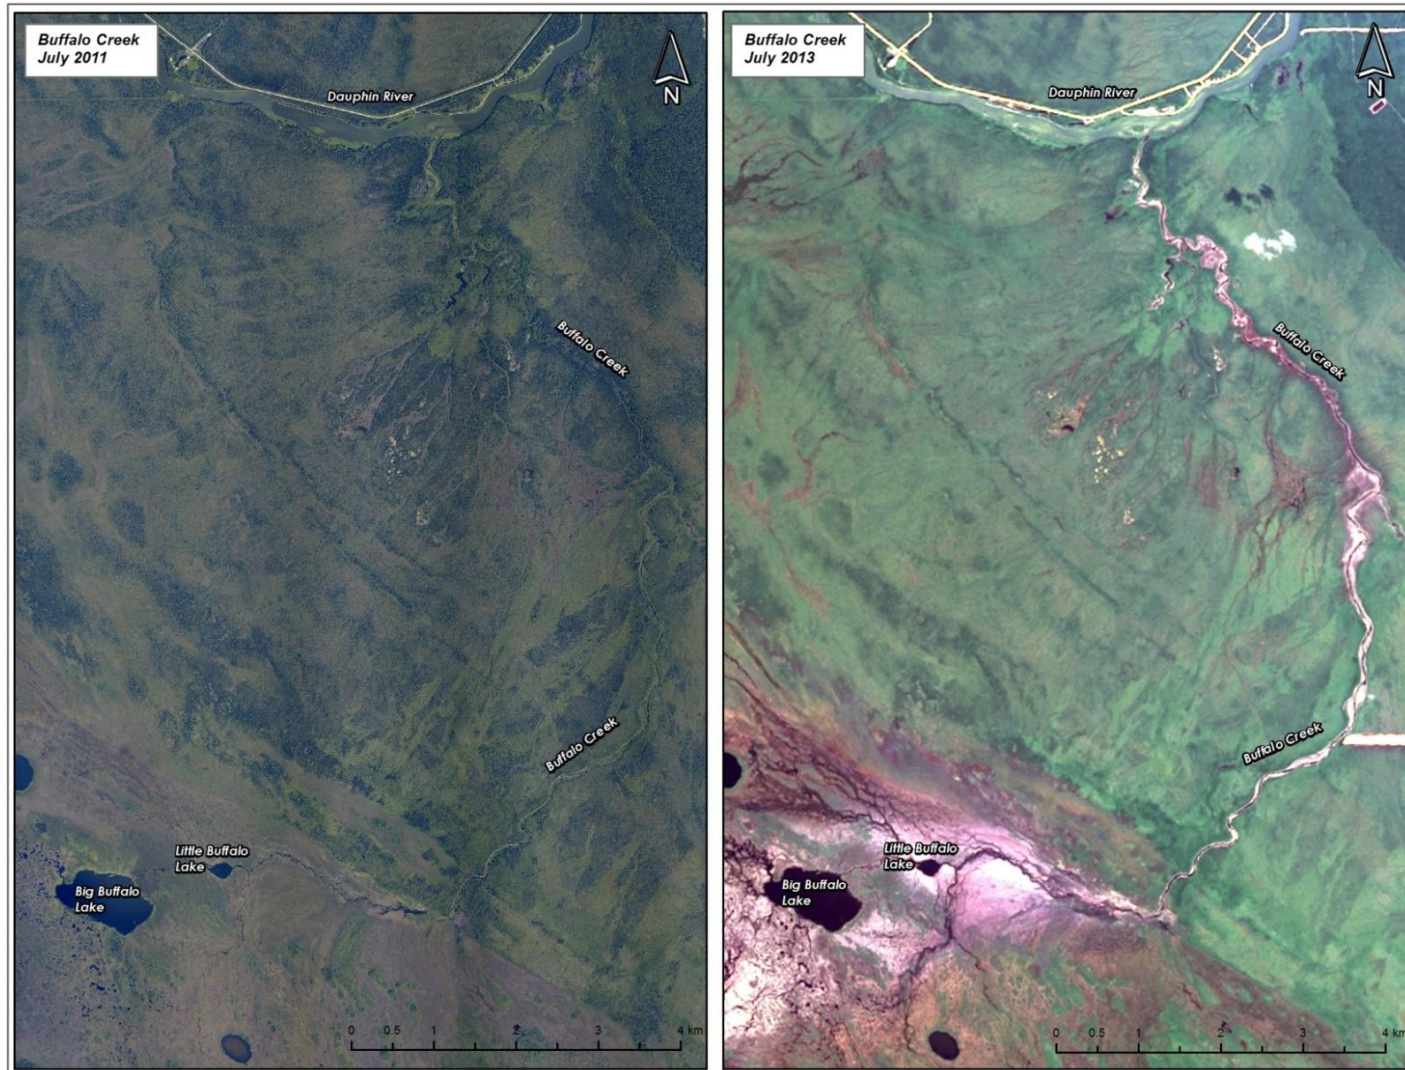
Figure 6.4-12. Satellite image overview of the Buffalo Creek watershed comparing Pre-Operation (July 2011) and 2011/2012 Closure (July 2013). Areas of bare soil resulting from flooding appear bright white, while light to dark brown areas are dead shrubs and trees.

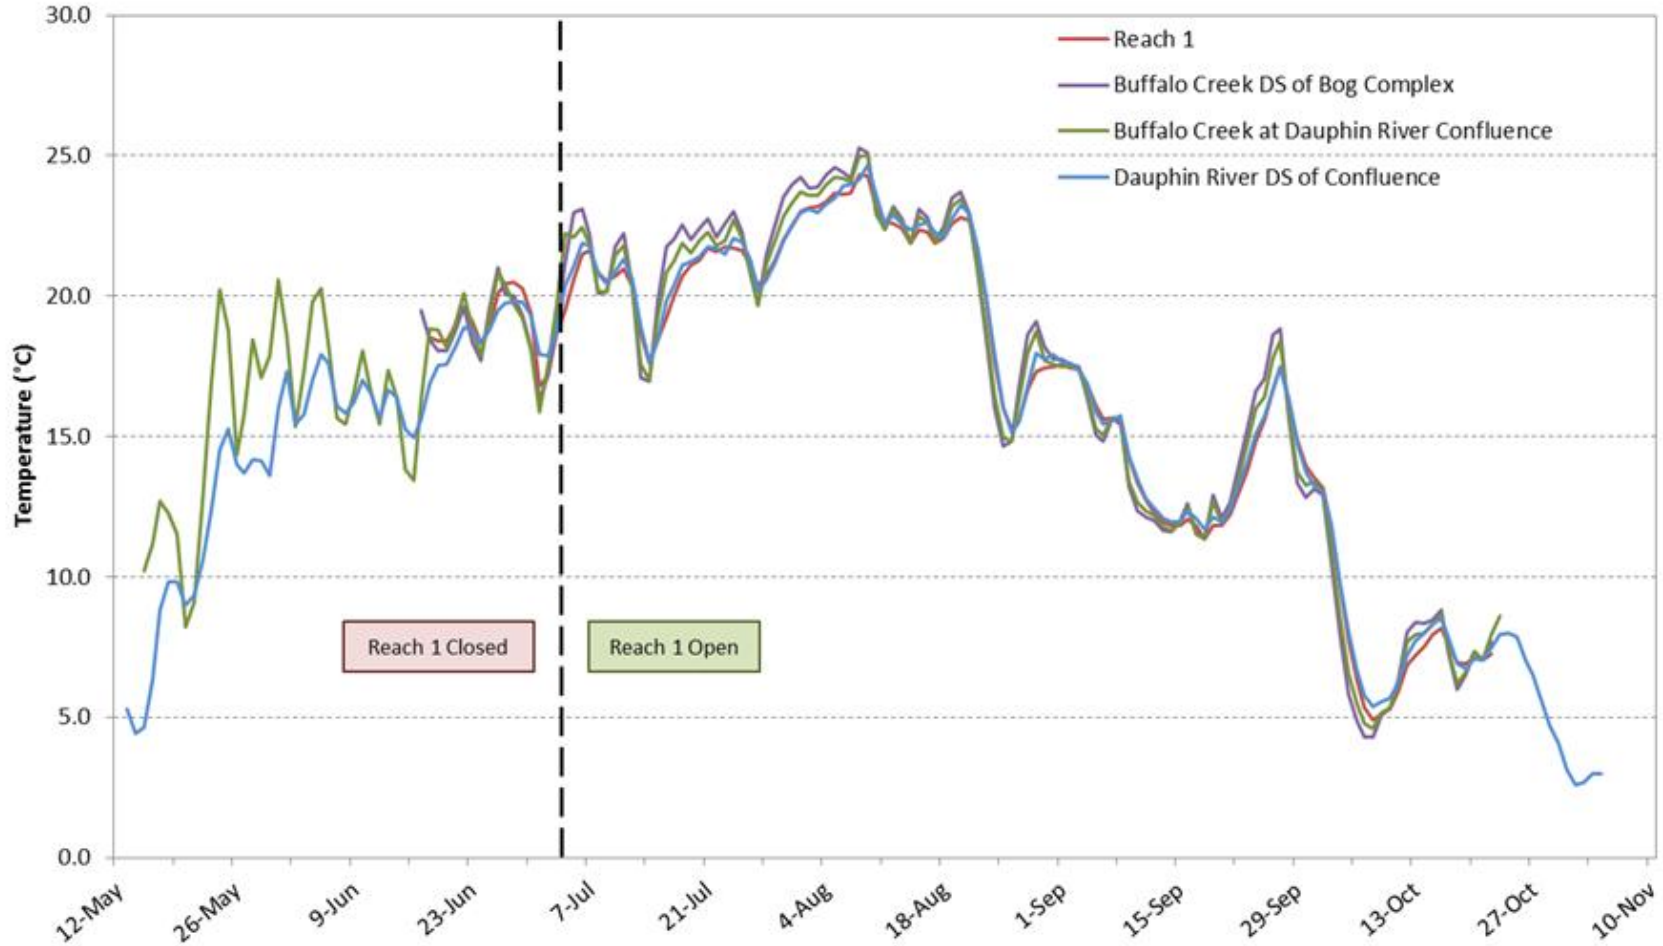
Figure 6.4-13. Water temperature data from Reach 1, Buffalo Creek, and the Dauphin River during the 2014 open water season.

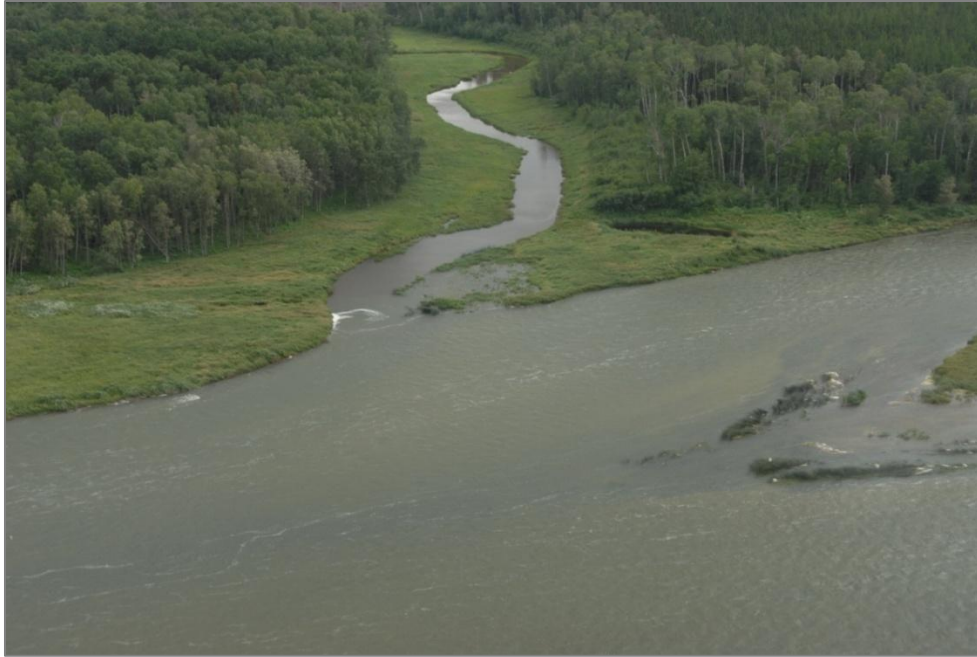
Figure 6.4-19. Aerial photograph of the Buffalo Creek and Dauphin River confluence during Pre-Operation.

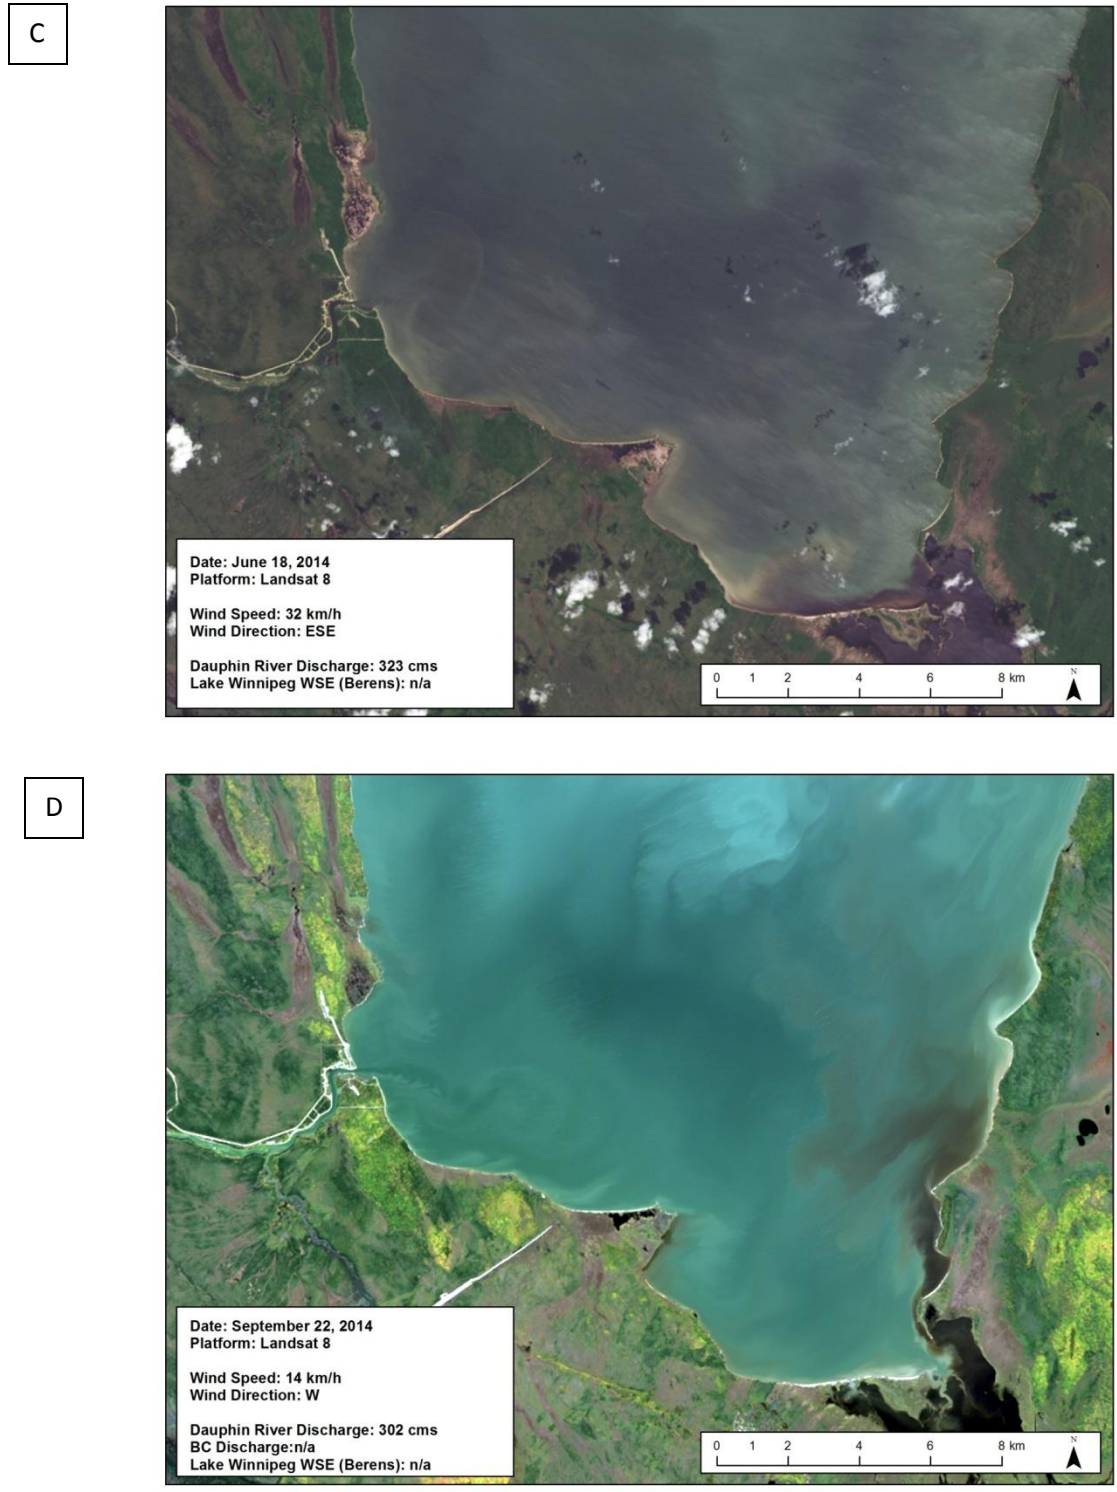
Figure 6.6-9. Satellite imagery of Sturgeon Bay under different wind conditions during the 2011 Flood period (A and B), 2011/2012 Closure (C), and 2014/2015 Operation (D).

Selected Landsat images (Table 6.2-4) were used to show the dynamic and turbid nature of Sturgeon Bay during variable wind conditions.

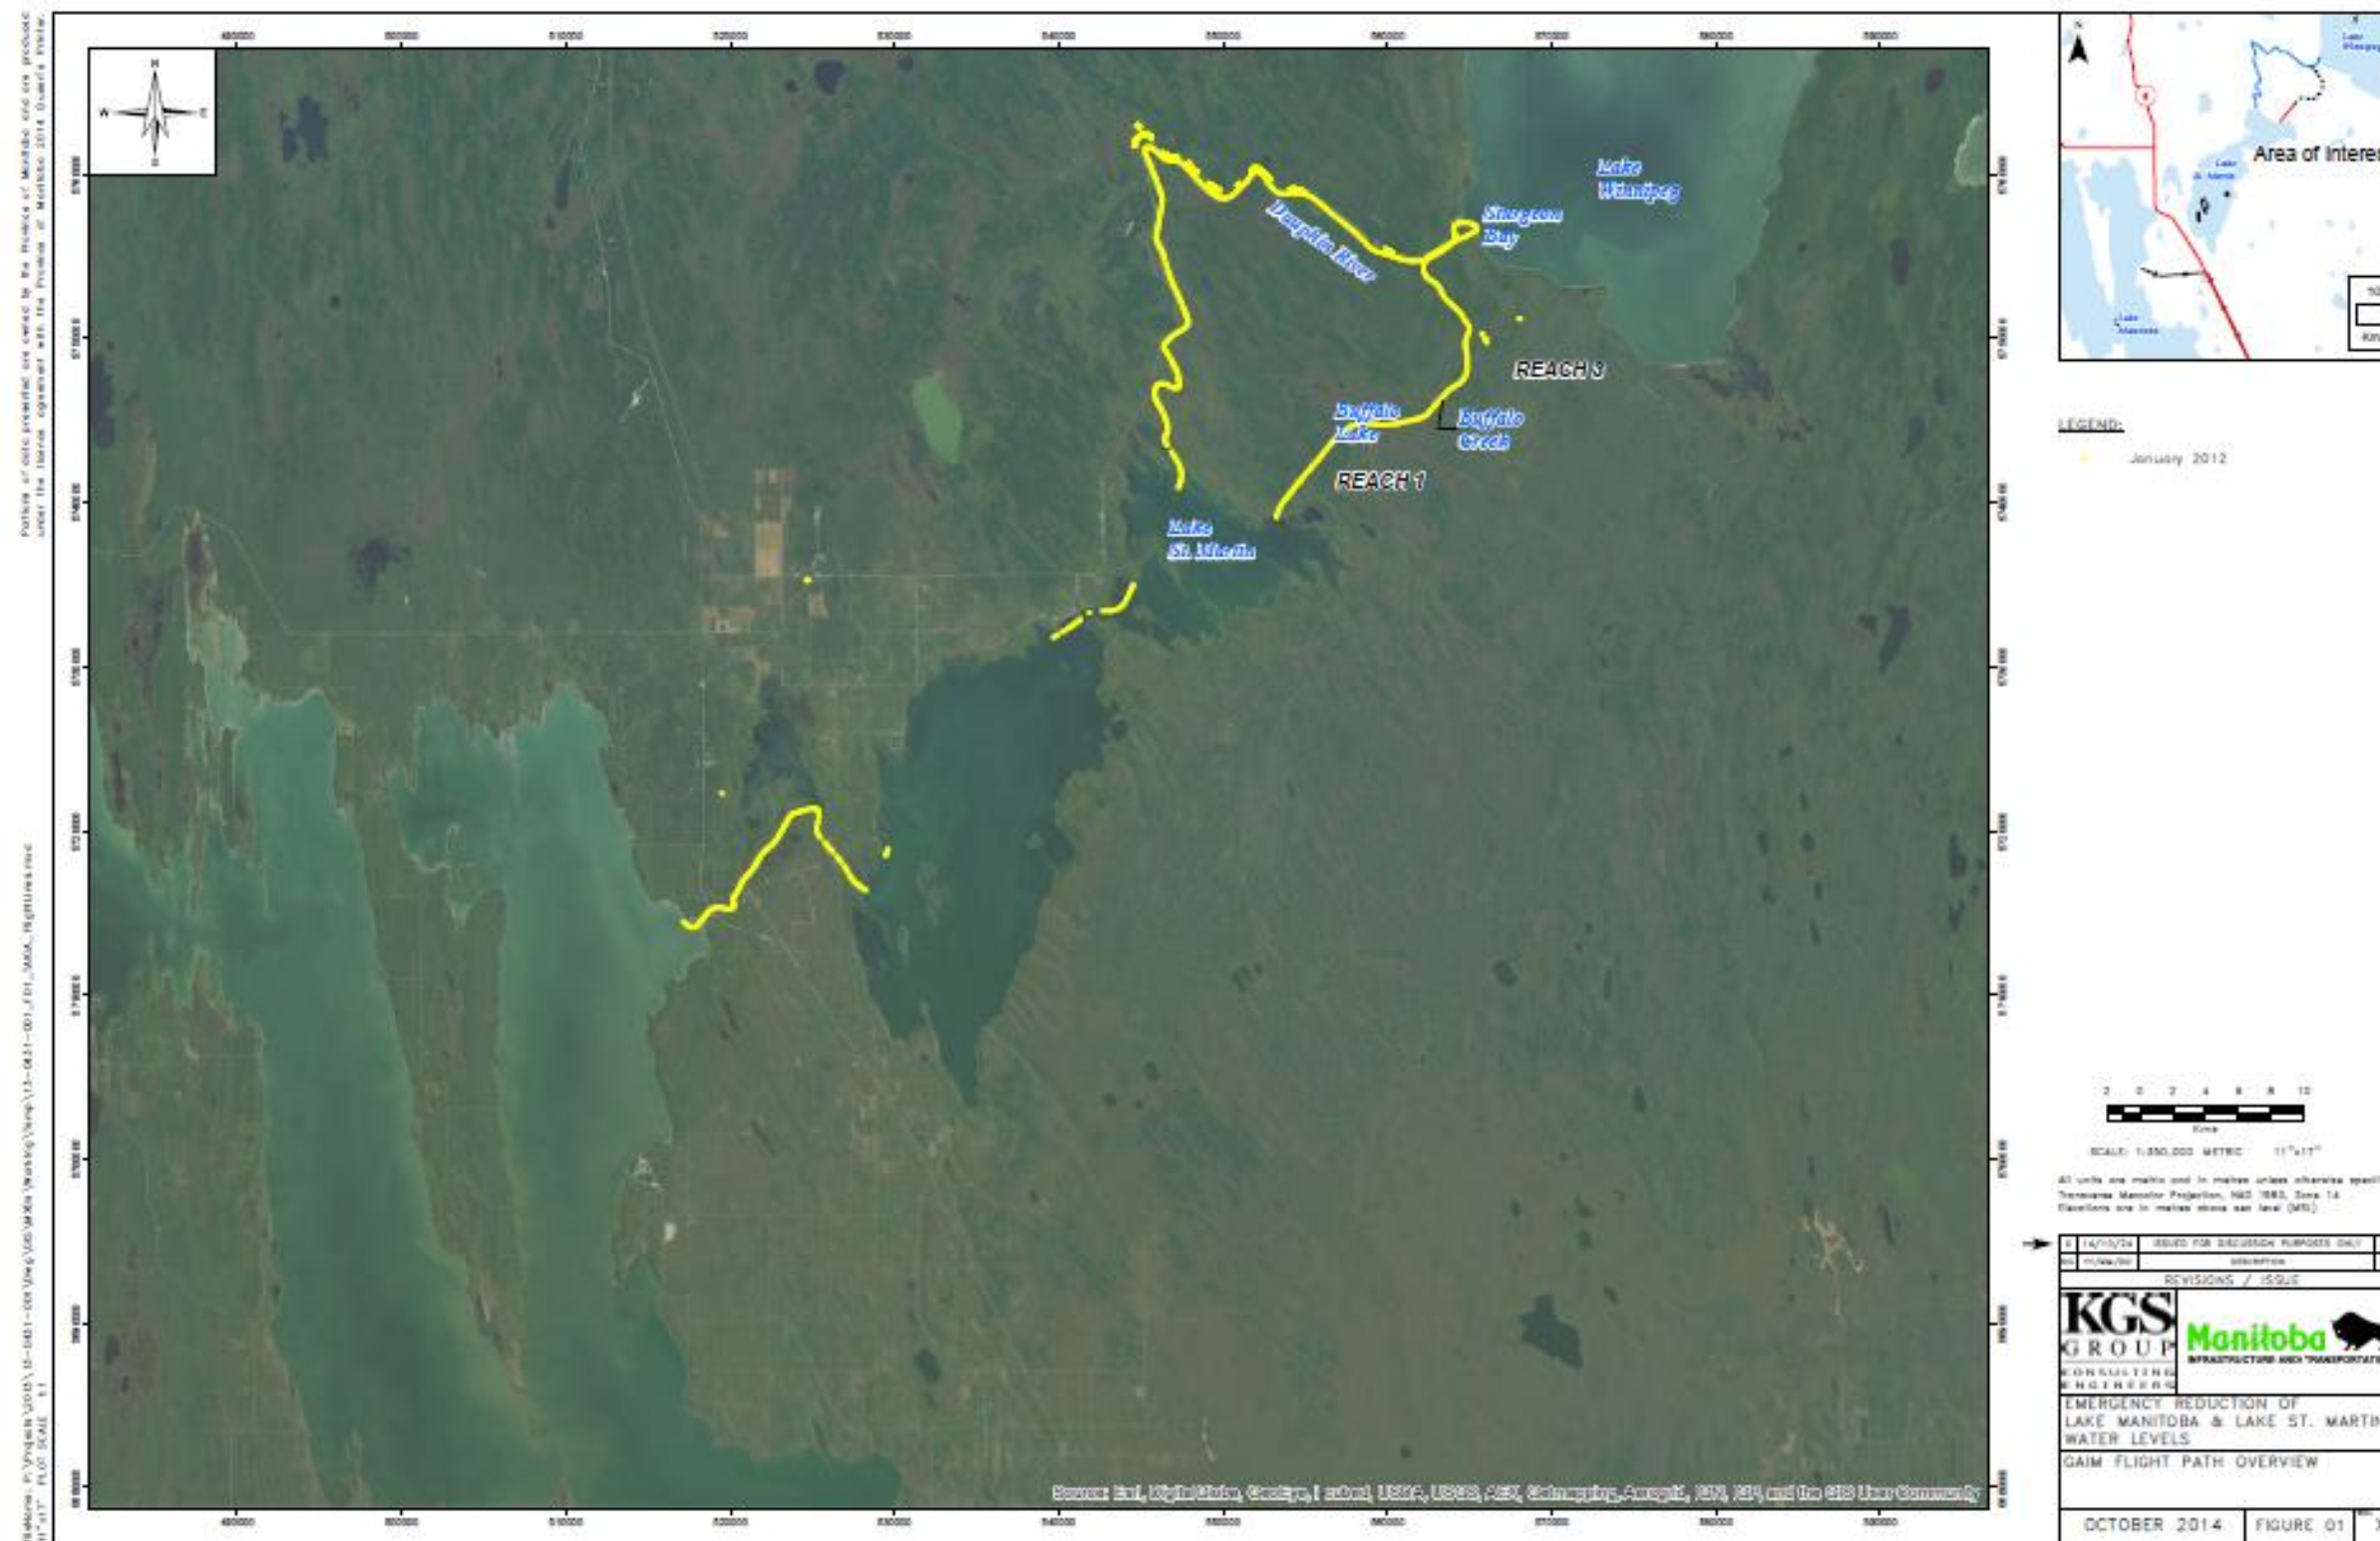
Figure 6B-2. Flight path for January 2012 GAIM data collection.

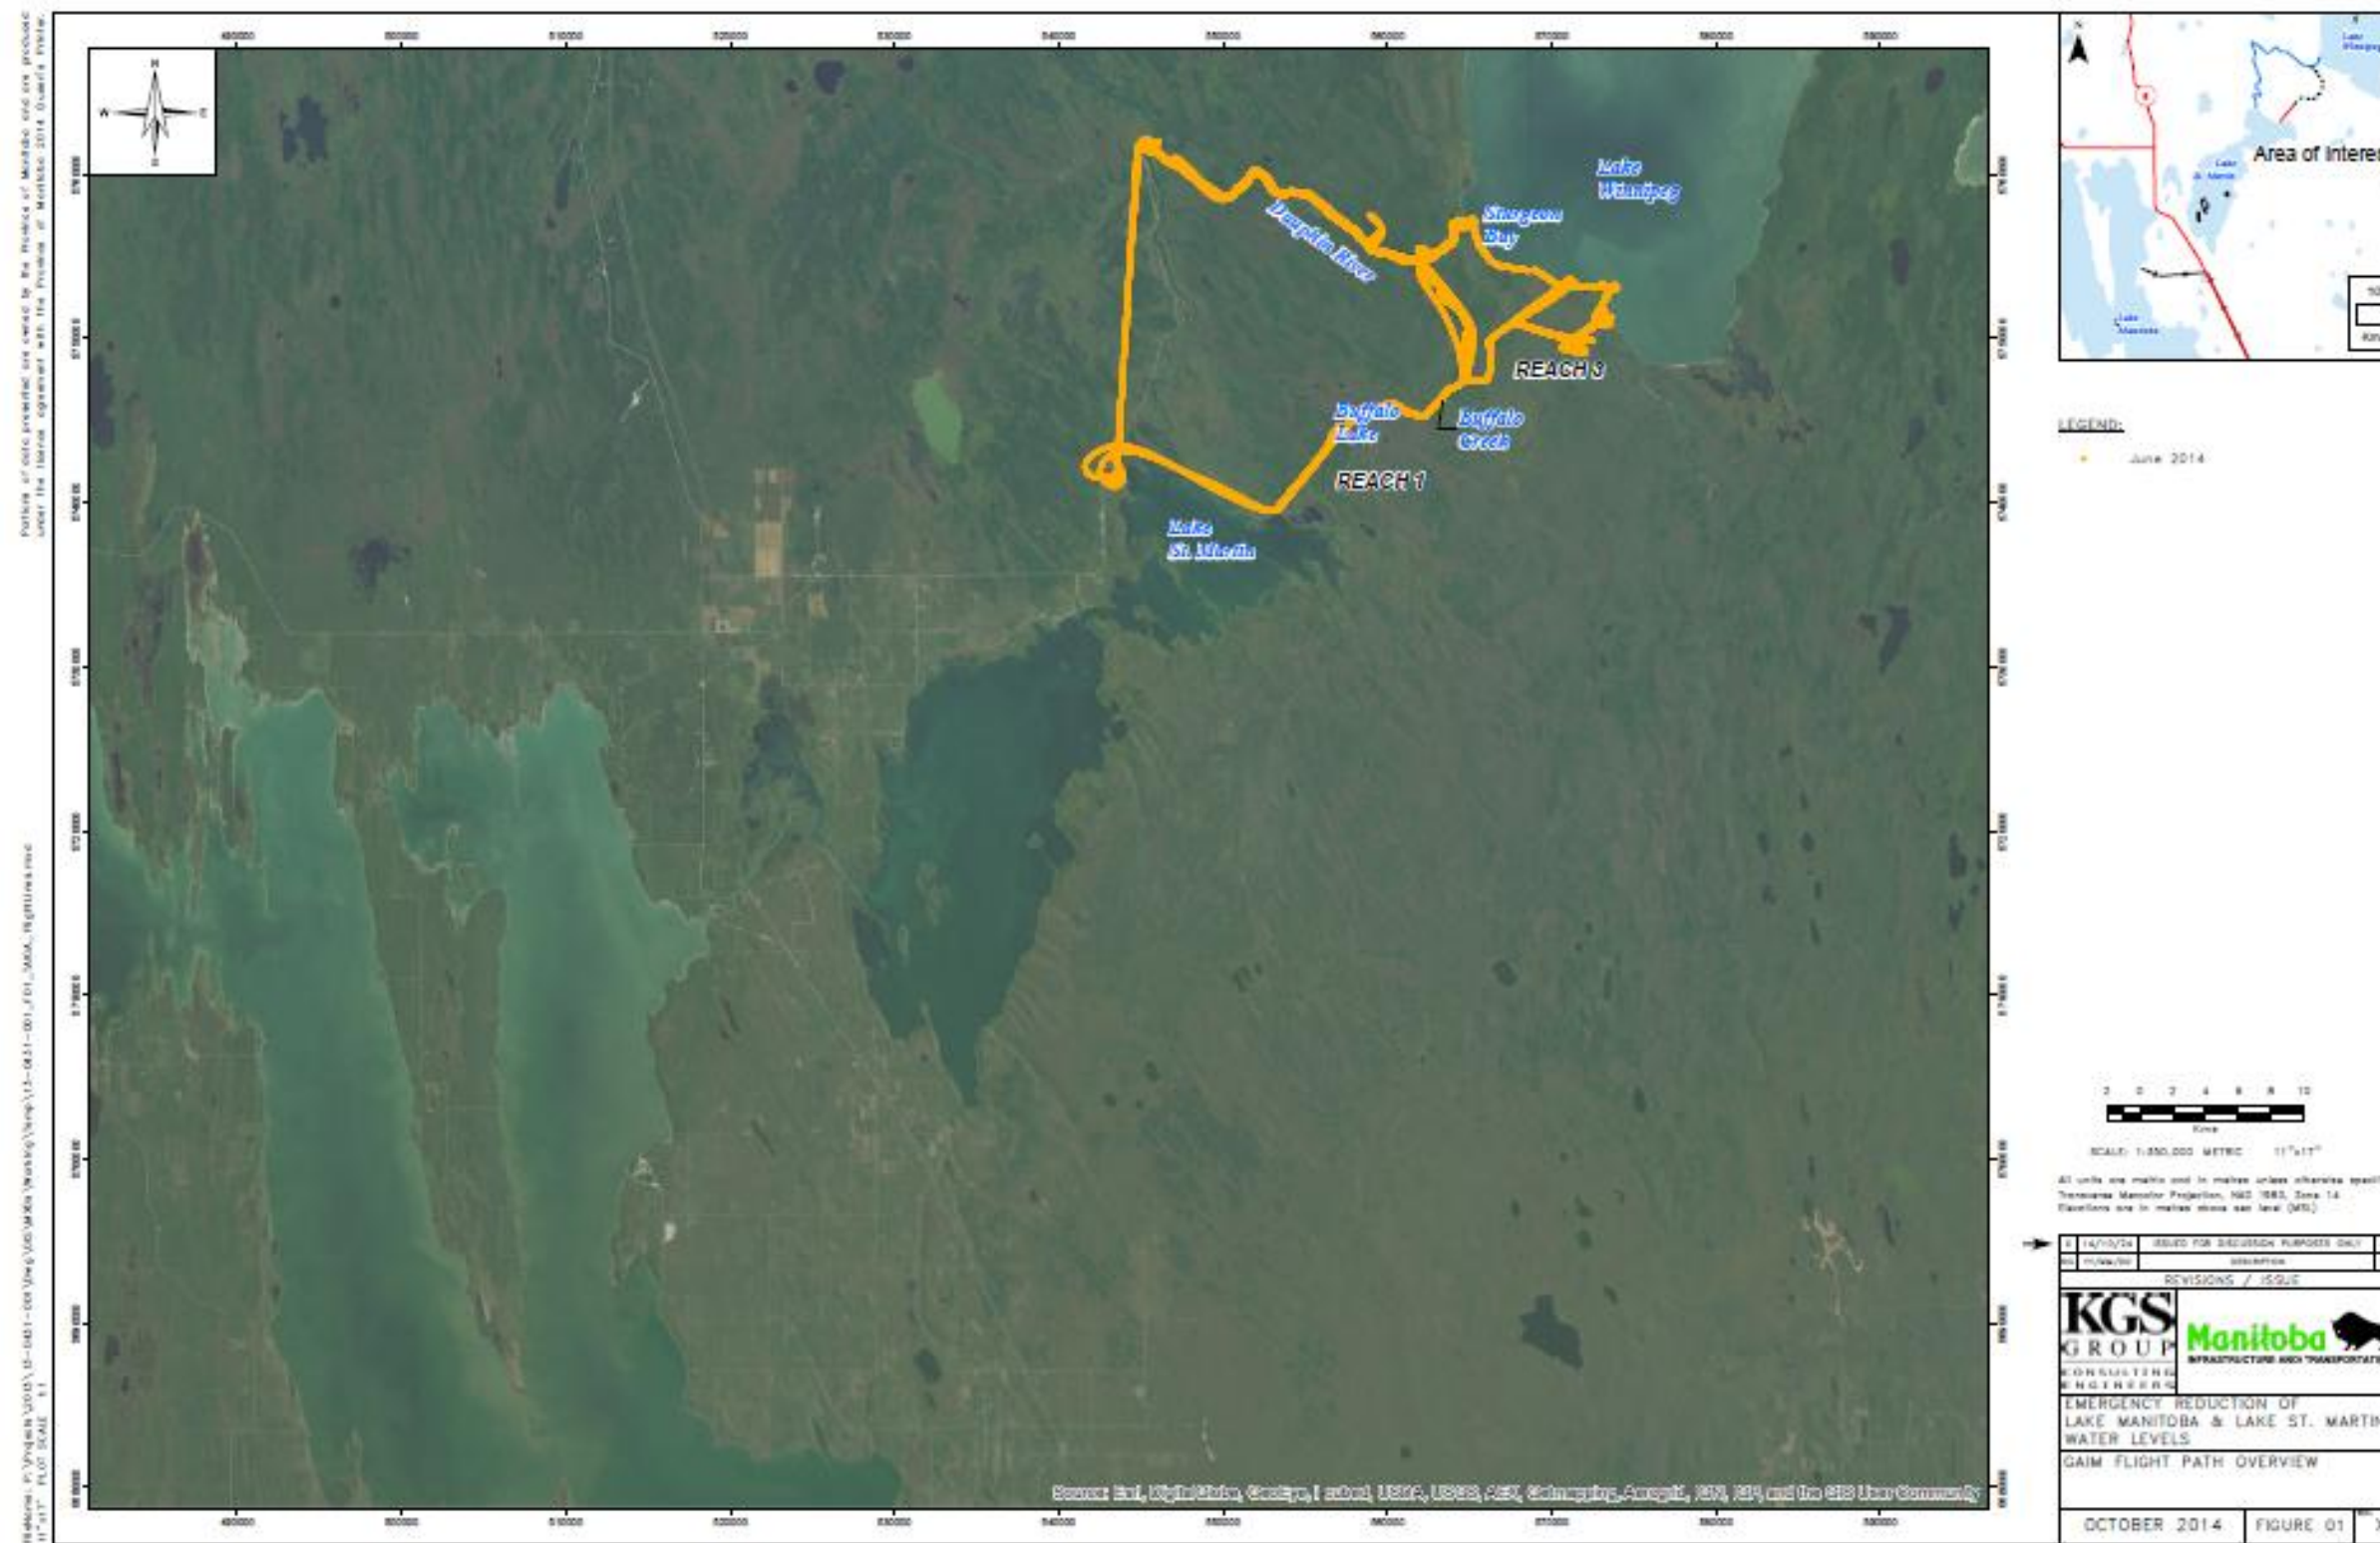
Figure 6B-4. Flight path for June 2014 GAIM data collection.
