**NOVA SCOTIA DEPARTMENT OF  
TRANSPORTATION AND PUBLIC WORKS**

**FISH SURVEY OF COKE OVENS BROOK  
AND MAID POND**

**JULY 6, 2001**

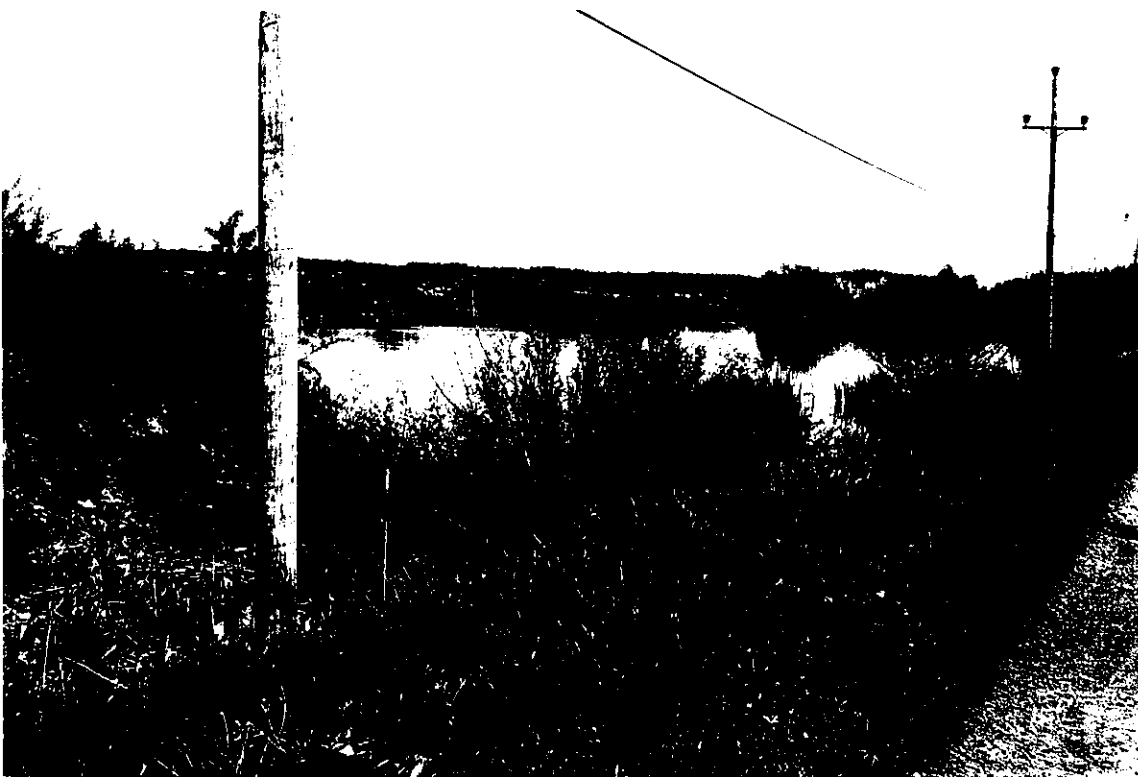
Fig. 3 - Maid Pond - Sites 10 and 11

The Brown Bullhead catfish [*Ictalurus nebulosus*] was found abundantly in the shallow, shoreline waters of Maid Pond (Fig. 3, 4) and, albeit in fewer numbers, further downstream in Coke Ovens Brook, just below the "toe ditch". All Bullheads appeared healthy.

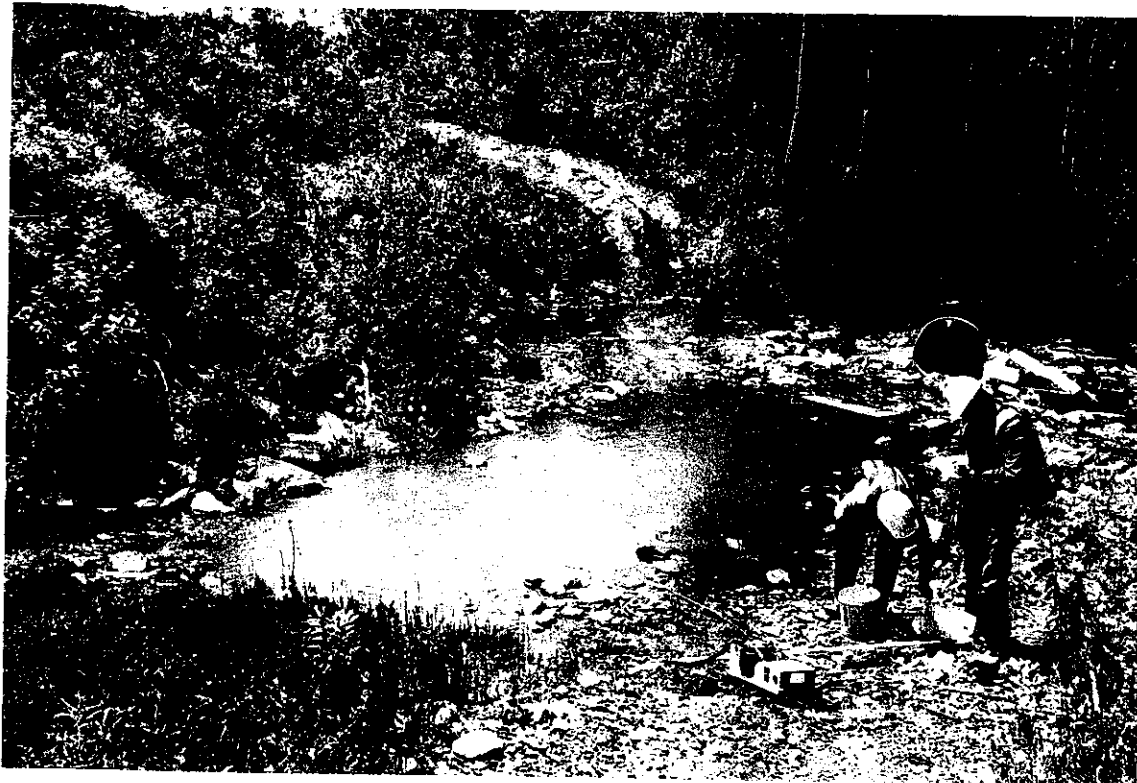
The physical habitat of Coke Ovens Brook is highly degraded because of poor water quality. Iron staining of the bottom substrate develops as Coke Ovens Brook passes around the toe of the landfill. This type of habitat can be seen in Fig. 5. A better type of habitat is seen in Fig. 6. A mummichog fish is seen in Fig. 7.

Fig. 5 - Coke Ovens Brook at Site 14
